**SAS Superstructure**

Location: 04-SF-80-13.2 / 13.9

Daily Diary Report by Bid Item

Contract No.: 04-0120F4

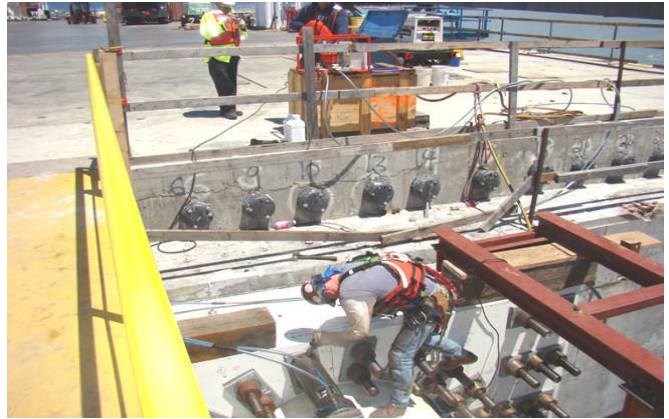
Performing the first lift-off on the top Macalloy rod that is in row 1 of the stressing sequence for the South W2E Hinge K pipe beam assembly.

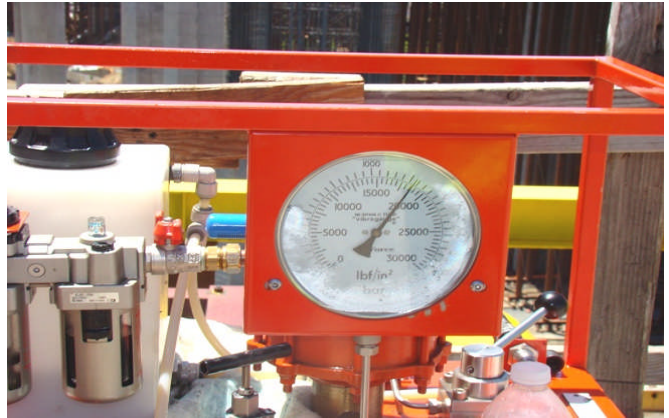
Observed gauge pressure on the loose Macalloy nut for the top Macalloy rod that is in row 1.
